Ref No: SA-007-2024

Slow speed gantry crane derailment

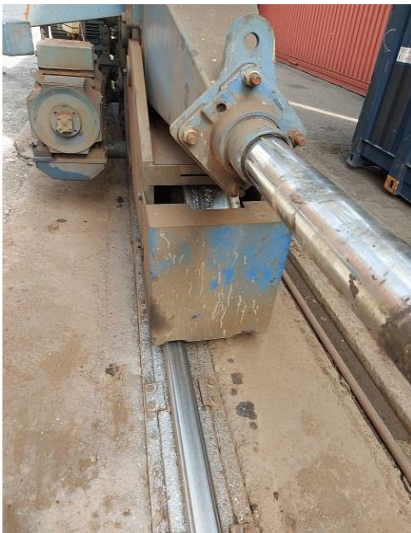
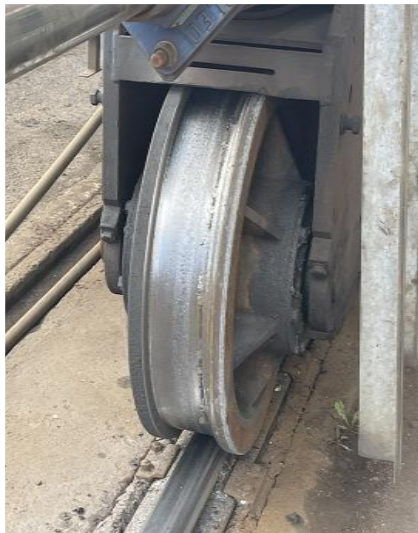
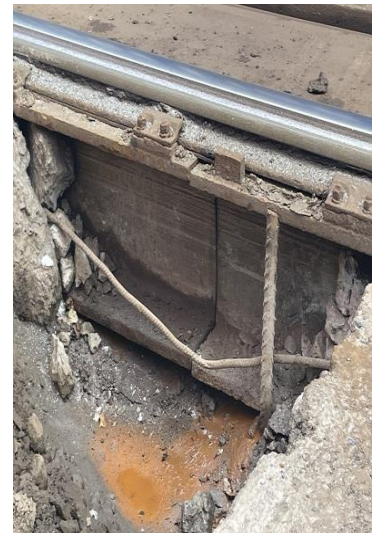
A rail mounted gantry crane, servicing visiting hauliers, had begun trolleying when the driver heard a loud noise from below and the crane came to a sudden stop. The driver contacted the engineering team for support who attended the scene and found that two of the leading crane wheels had become derailed from the rail.

- The flange of one of the leading crane wheels had cracked and fragmented, allowing the crane to deviate from the crane rail.

- A torque imbalance between the long travel motors on the crane resulted in increased lateral loading on the crane wheels.
- The lateral loading led to increased wear and subsequent material loss to the crane wheels and the rail itself.
- When the wheel flange thickness reduced below a critical level it fragmented, leading to the derailment.
- Rail deflection had been previously observed, and ground investigation work also highlighted four soft spots along the length of the inward crane rail, where the rail foundations had deteriorated.
- Pre-incident crane wheels had been visually inspected monthly, but wear measurements were not recorded or compared.

- Additional controls were introduced; including increased frequency of wheel flange thickness checks, the reduction of trolleying speed and a limitation to the distance travelled by the gantry crane.
- A project to replace existing long travel motors and eliminate 'crabbing' has been expedited.
- Work has commenced to stabilise the deterioration of concrete under the crane rail and strengthen the foundation.
- A significant portion of the crane rail has been identified for renewal.
- Periodic review of asset management and maintenance programmes will be conducted to ensure ongoing understanding of lifecycle and upgrade requirements.
